Mr. & Mrs. Homebuyer
101 Paradise Way
Anytown, CA 93311

Jabuka Home Inspections
661/664-8629
Serving all of Kern County

INSPECTION INFORMATION

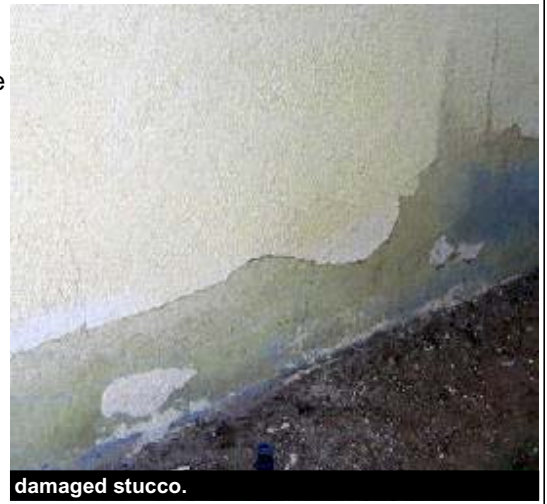
307 STUCCO SIDING

with exceptions noted.
 a. [CR] The stucco siding was damaged/deteriorated at the right side and garage of the building. These conditions are conducive to moisture intrusion/deterioration. We recommend correcting the condition(s) noted.

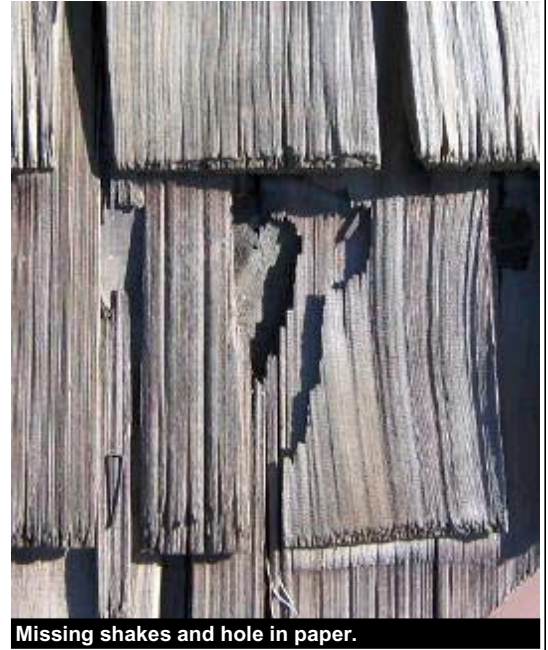
408 WOOD SHAKES

with exceptions noted.
 a. [FE] There were a number of wood shakes that were broken, eroded or slipped out of place exposing the underlayment felt to the weather. These conditions are conducive to roof leaks. We recommend a full evaluation and/or corrections by a specialist in the appropriate trade.

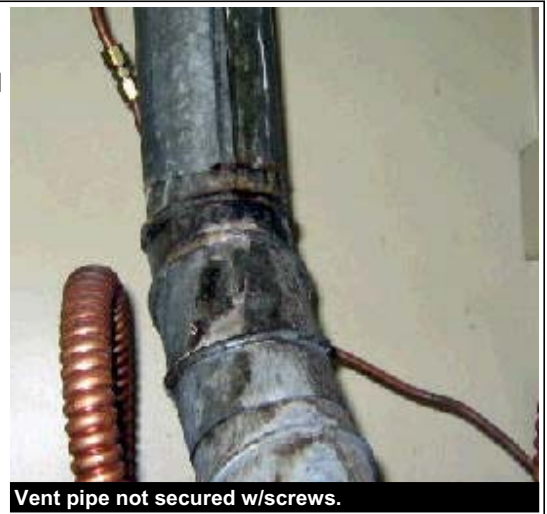
707 VENTING SYSTEM(S)

with exceptions noted.
a. [SC] The flue vent pipe was not secured as required. We recommend correcting the condition(s) noted.

Vent pipe not secured w/screws.

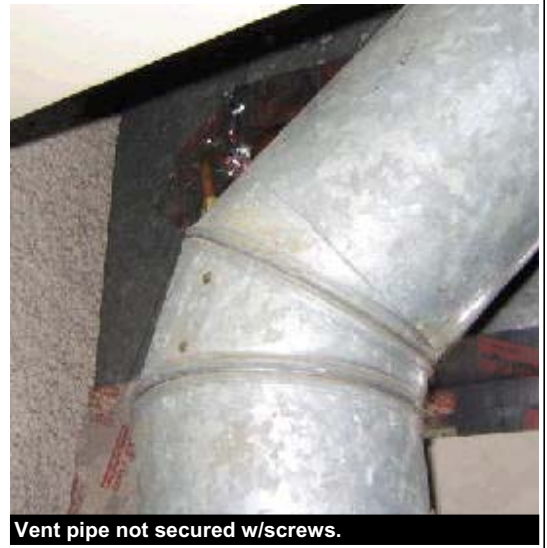
908 VENTING SYSTEM(S)

with exceptions noted.
a. [SC] The flue vent pipe was not secured. We recommend correcting the condition(s) noted.

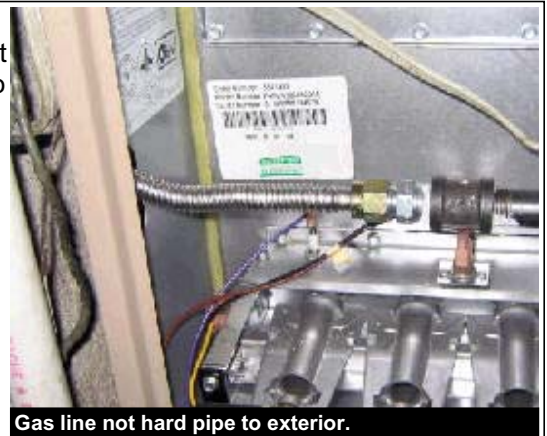
912 ENERGY SUPPLY(S)

with exceptions noted.
a. [SC] The furnace was a newer unit and the gas line was not hard piped to the exterior of the furnace housing. We recommend correcting the condition(s) noted.

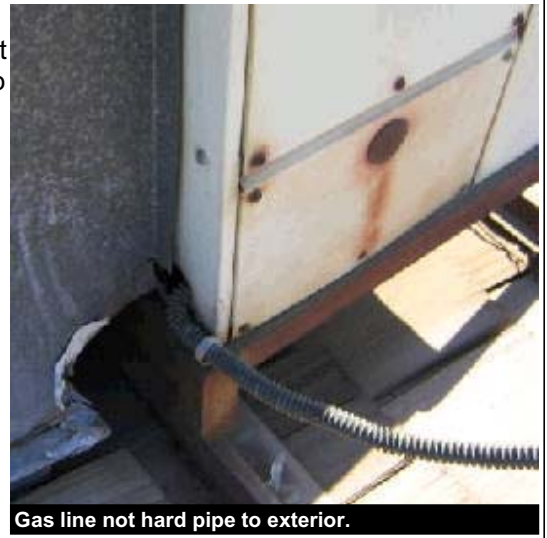
912 ENERGY SUPPLY(S)

with exceptions noted.
a. [SC] The furnace was a newer unit and the gas line was not hard piped to the exterior of the furnace housing. We recommend correcting the condition(s) noted.

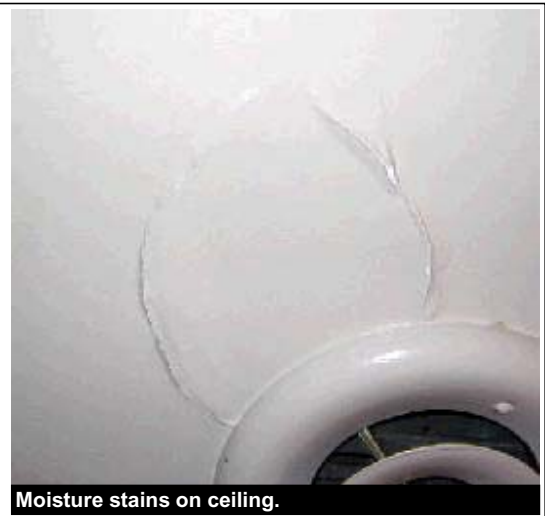
1301 WALL(S)/CEILING(S)

with exceptions noted.
a. [CR] Moisture/stains were noted on the ceiling. The area tested dry during the inspection. We recommend locating and correcting the source as well as any damaged materials.
b. [FE] Past repairs were noted on the wall(s)/ceiling. We recommend inquiring about the condition(s) noted.

Moisture stains on ceiling.

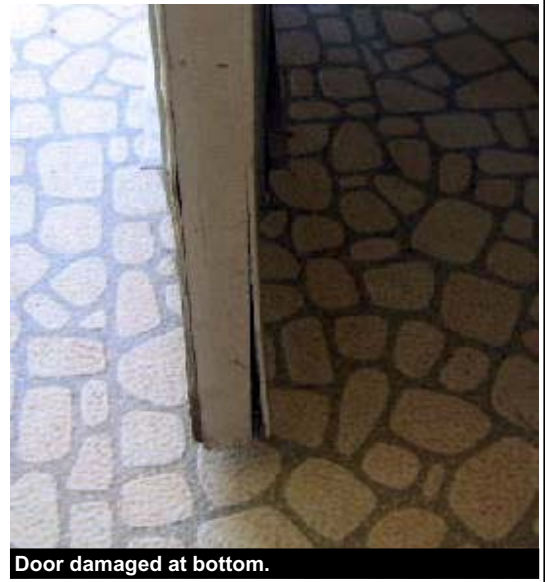
.b. [CR] The door knob-set was loose/damaged/had missing parts. We recommend correcting the condition(s) noted

.c. [CR] The door(s) were damaged/deteriorated. We recommend correcting the condition(s) noted.

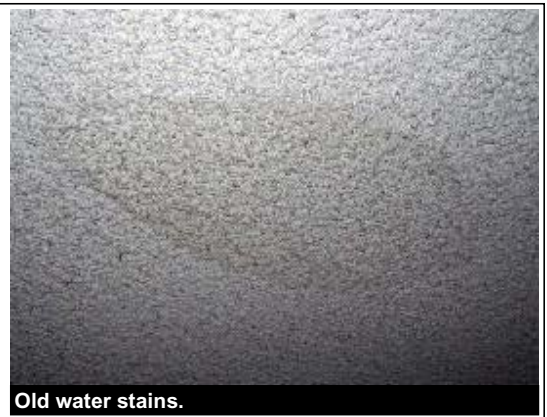
1408 WALL(S)/CEILING(S)

with exceptions noted.
a. [CR] Moisture/stains were noted on the ceiling. The area tested dry during the inspection. We recommend locating and correcting the source as well as any damaged materials.

Old water stains.

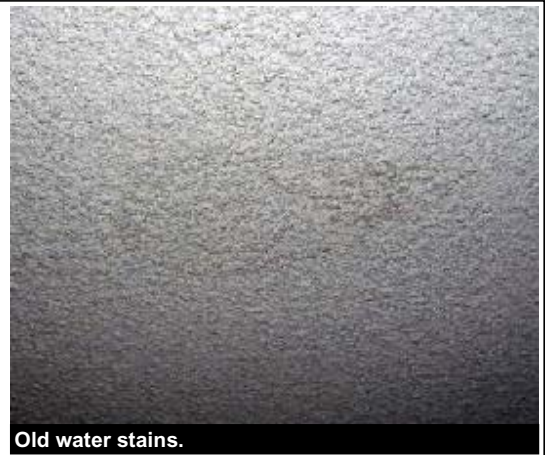
1408
WALL(S)/CEILING(S)

with exceptions noted.
a. [CR] Moisture/stains were noted on the ceiling. The area tested dry during the inspection. We recommend locating and correcting the source as well as any damaged materials.

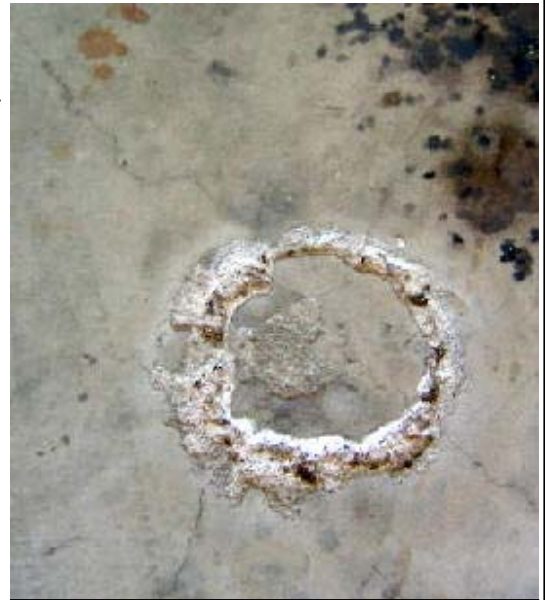
1515 GARAGE FLOOR(S)

with exceptions noted.
a. [FE] There were efflorescence (white mineral salts) stains on the floor. This condition is an indication of moisture intrusion. We recommend locating and correcting the source as well as any damaged materials.

Efflorescence stains on carport floor.

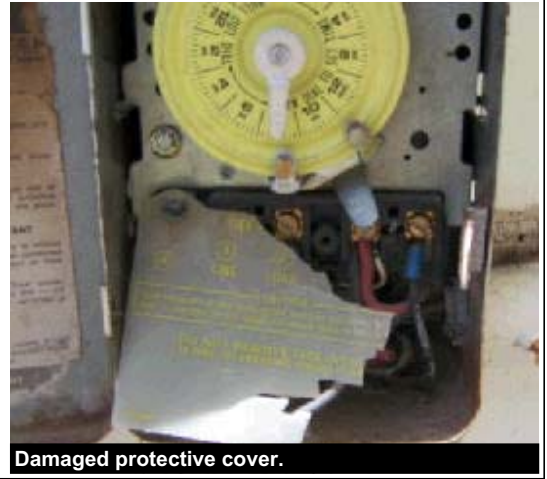
1644 CONTROLS

with exceptions noted.
a. [SC] The protective "dead front" cover was missing from the panel. We recommend correcting the condition(s) noted.

Damaged protective cover.
