Mr. & Mrs. Homebuyer
101 Paradise Way
Anytown, CA 93311

Jabuka Home Inspections
661/664-8629
Serving all of Kern County

INSPECTION INFORMATION

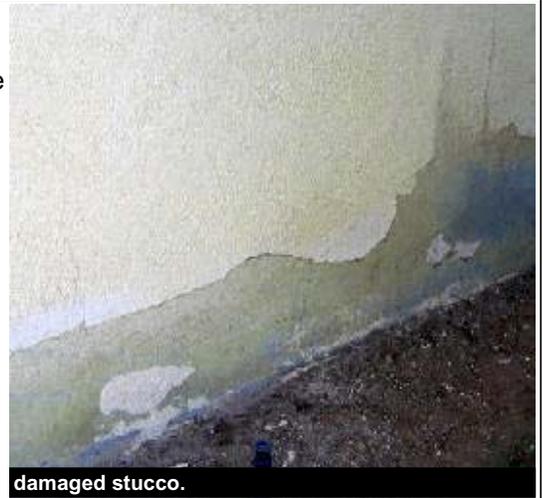
307 STUCCO SIDING

with exceptions noted.
 a. [CR] The stucco siding was damaged/deteriorated at the right side and garage of the building. These conditions are conducive to moisture intrusion/deterioration. We recommend correcting the condition(s) noted.

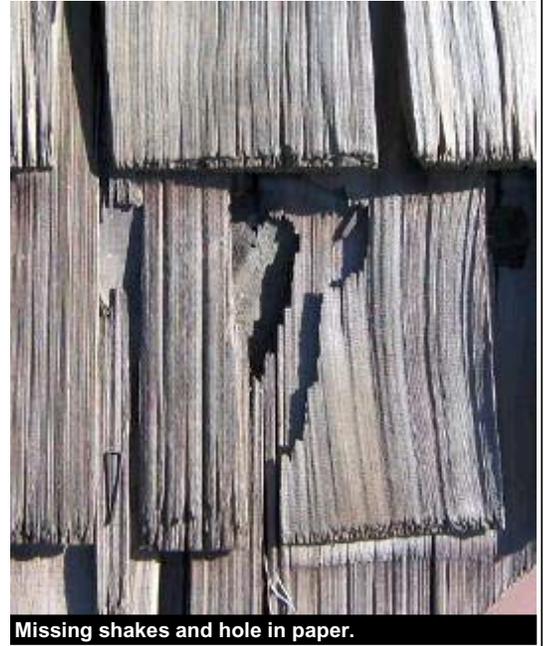
408 WOOD SHAKES

with exceptions noted.
 a. [FE] There were a number of wood shakes that were broken, eroded or slipped out of place exposing the underlayment felt to the weather. These conditions are conducive to roof leaks. We recommend a full evaluation and/or corrections by a specialist in the appropriate trade.

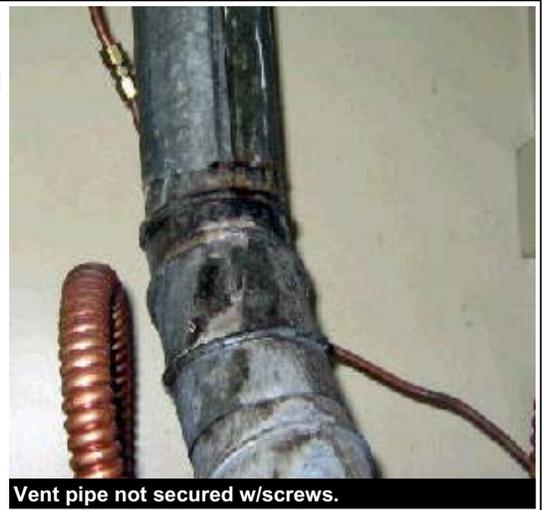
707 VENTING SYSTEM(S)

with exceptions noted.
a. [SC] The flue vent pipe was not secured as required. We recommend correcting the condition(s) noted.

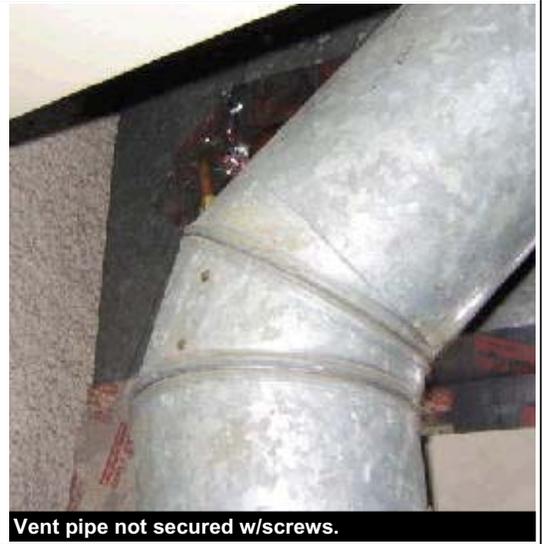
908 VENTING SYSTEM(S)

with exceptions noted.
a. [SC] The flue vent pipe was not secured. We recommend correcting the condition(s) noted.

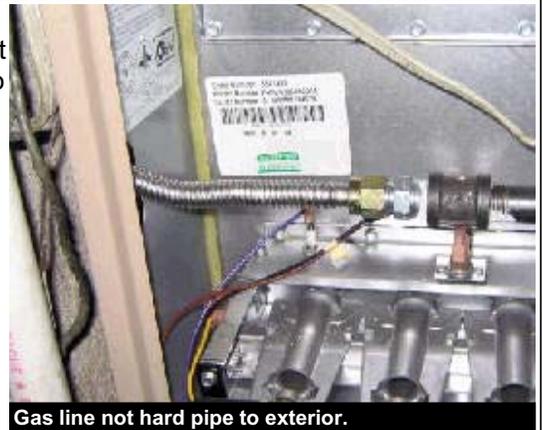
912 ENERGY SUPPLY(S)

with exceptions noted.
a. [SC] The furnace was a newer unit and the gas line was not hard piped to the exterior of the furnace housing. We recommend correcting the condition(s) noted.

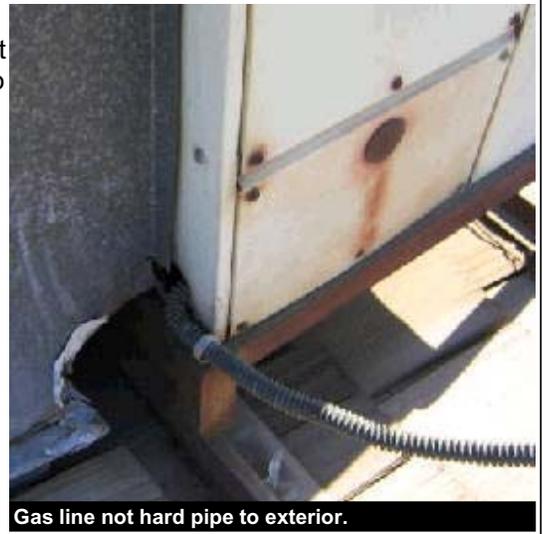
912 ENERGY SUPPLY(S)

with exceptions noted.
a. [SC] The furnace was a newer unit and the gas line was not hard piped to the exterior of the furnace housing. We recommend correcting the condition(s) noted.

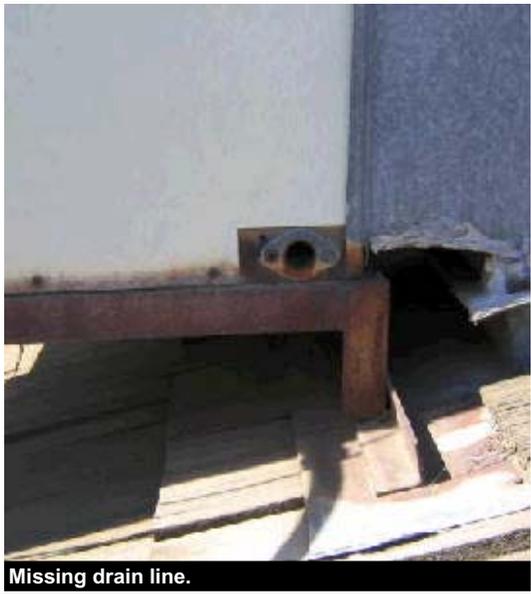
| 1010 CONDENSATE DRAIN LINE(S) | <p>with exceptions noted. a. [CR] The condensate drain line was damaged/disconnected. We recommend correcting the condition(s) noted.</p> |

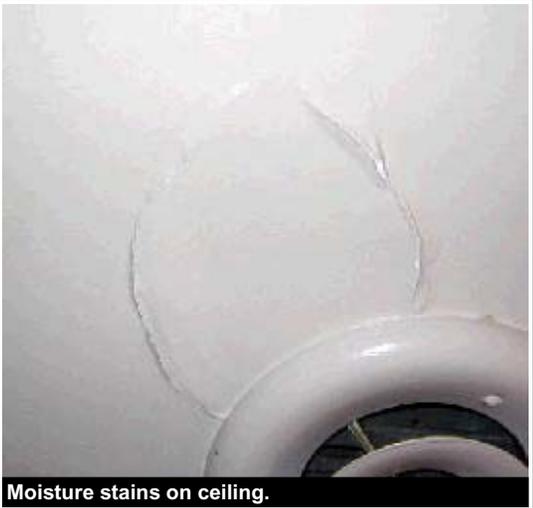
| 1301 WALL(S)/CEILING(S) | <p>with exceptions noted.</p> <p>a. [CR] Moisture/stains were noted on the ceiling. The area tested dry during the inspection. We recommend locating and correcting the source as well as any damaged materials.</p> <p>b. [FE] Past repairs were noted on the wall(s)/ceiling. We recommend inquiring about the condition(s) noted.</p> |

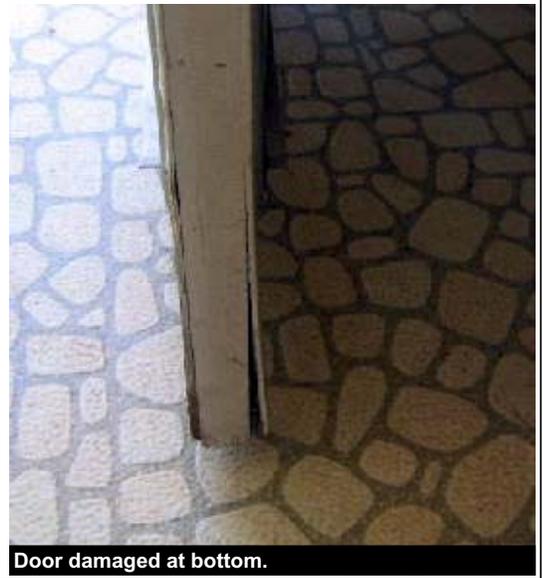
.c. [CR] The door(s) were damaged/deteriorated. We recommend correcting the condition(s) noted.

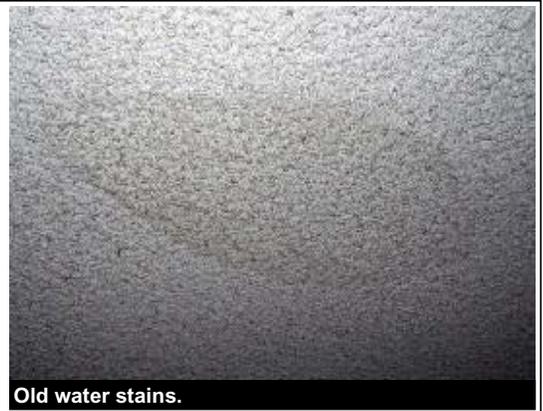
1408 WALL(S)/CEILING(S)

with exceptions noted.
a. [CR] Moisture/stains were noted on the ceiling. The area tested dry during the inspection. We recommend locating and correcting the source as well as any damaged materials.

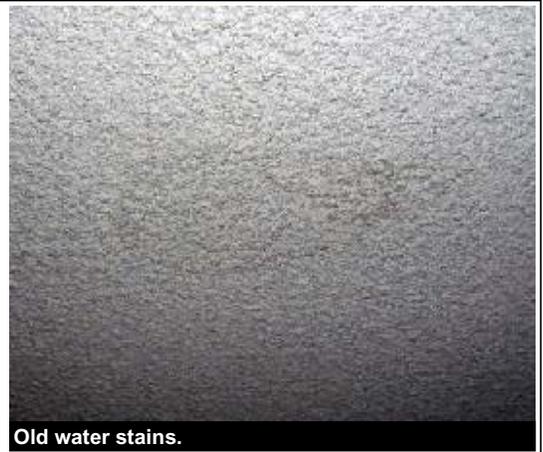
1408
WALL(S)/CEILING(S)

with exceptions noted.
a. [CR] Moisture/stains were noted on the ceiling. The area tested dry during the inspection. We recommend locating and correcting the source as well as any damaged materials.

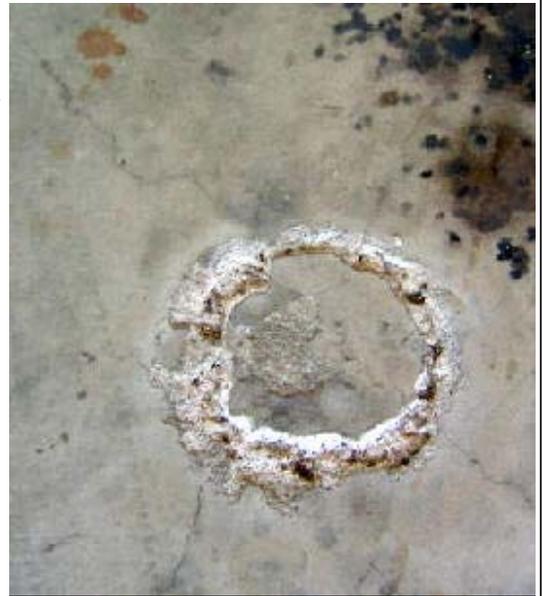
1515 GARAGE FLOOR(S)

with exceptions noted.
a. [FE] There were efflorescence (white mineral salts) stains on the floor. This condition is an indication of moisture intrusion. We recommend locating and correcting the source as well as any damaged materials.

Efflorescence stains on carport floor.

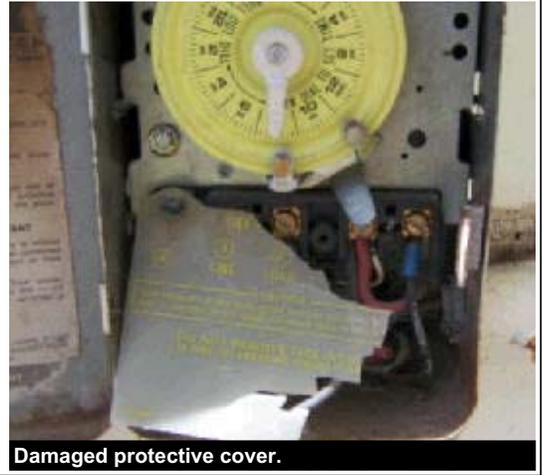
1644 CONTROLS

with exceptions noted.
a. [SC] The protective "dead front" cover was missing from the panel. We recommend correcting the condition(s) noted.

Damaged protective cover.
